# Manhole Inspection Summary

Manhole # S29KK1013MH

**Inspection** ☐ Is Incomplete Rating: **4) Poor**

**Location** Address: **4323 WICKFORD RD**

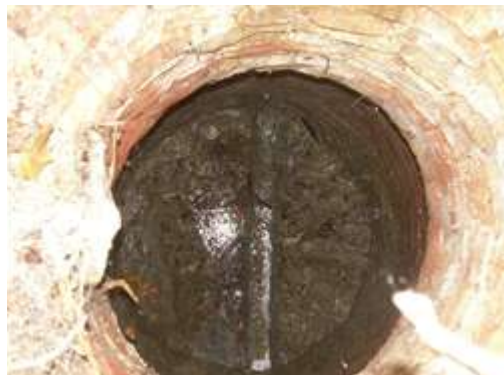
Top View

**Bench** ☒ Exists Material: **Brick** ☐ Parged ☒ **Debris** (not Condition related)

**Steps** Count: **6** Missing: **6** ☒ **Corroded**

Corroded and missing steps. Bench debris.

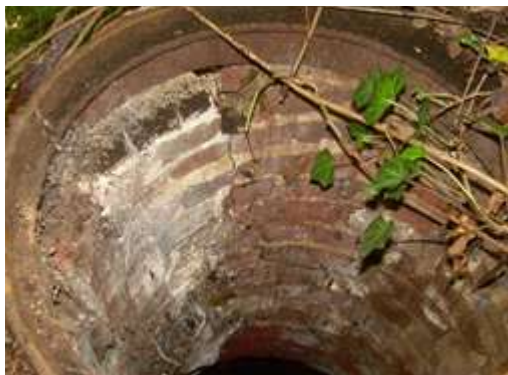
Defect

**Chimney / Frame Adjustment** ☒ Exists Material: **Brick** ☐ Parged Height: **27** (in.)

Condition: ☐ Sound ☐ Cracked ☐ Root Intrusion ☐ Loose Brick ☒ **Deteriorated**

Infiltration: ☐ None ☒ **Joint** ☐ Cracks ☐ Mortar ☐ Roots ☒ **Wall**

Adjustment deterioration and infiltration

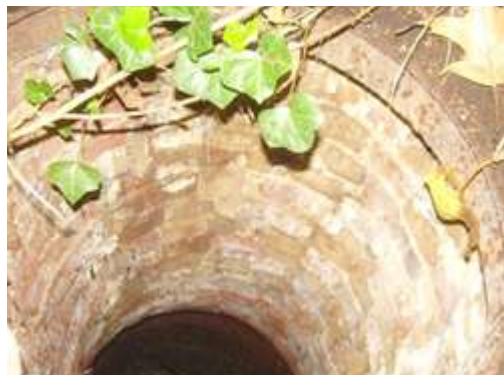
Defect

Adjustment deterioration and infiltration - other side.

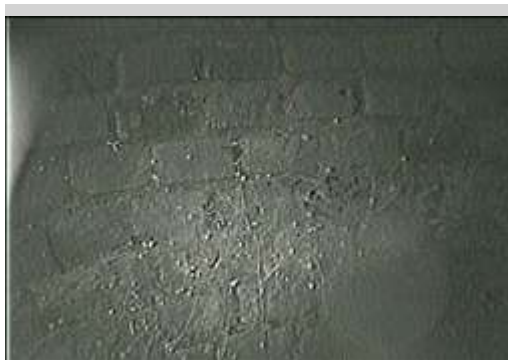
Defect

Condition: ☐ Sound ☐ Cracked ☒ **Root Intrusion** ☐ Loose Brick ☐ Deteriorated

Infiltration: ☐ None ☐ Joint ☐ Cracks ☒ **Mortar** ☒ **Roots** ☒ **Wall**

Corbel root intrusion and infiltration.

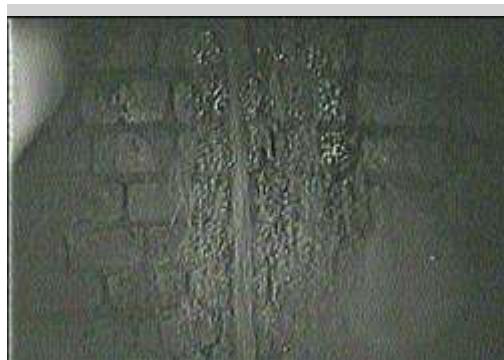
Defect

Condition: ☐ Sound ☐ Cracked ☒ **Root Intrusion** ☐ Loose Brick ☐ Deteriorated

Infiltration: ☐ None ☐ Joint ☐ Cracks ☒ **Mortar** ☒ **Roots** ☒ **Wall**

Barrel root intrusion and infiltration

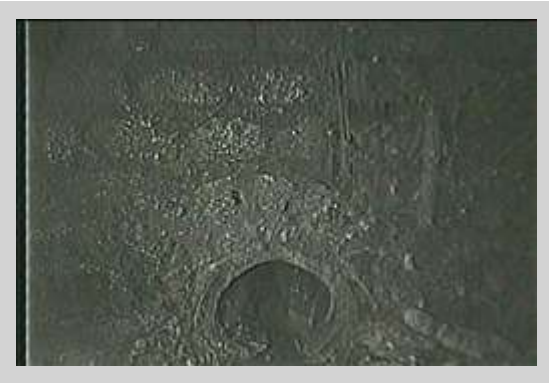
### 8 in. Circular Gravity Sewer Pipe Out @ 12 O'Clock

Barrel deterioration, root intrusion and infiltration.

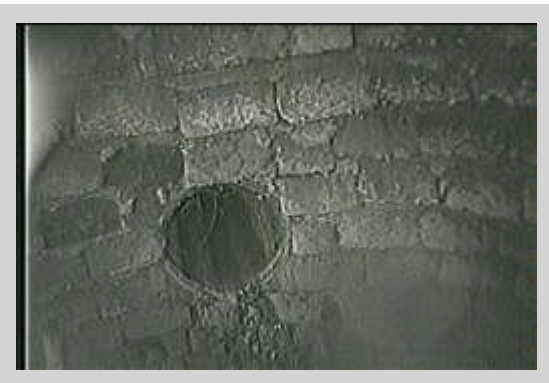
### 8 in. Circular Gravity Sewer Pipe In @ 6 O'Clock

Infiltration: **Evidence** Pipe Seal Cond: **Cracked**

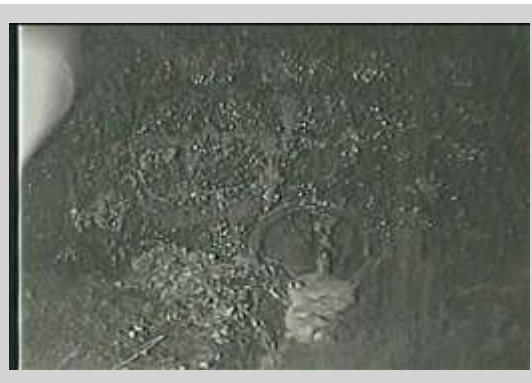
### Drop In @ 6 O'Clock

Drop Condition: **Partly Clogged**
